Blue River Fish Barrier Monitoring

Paul C. Marsh, Brian R. Kesner, Jason C.G. Marsh

Marsh & Associates, LLC
5016 S. Ash Avenue, Suite 108
Tempe, Arizona 85282

December 30, 2013

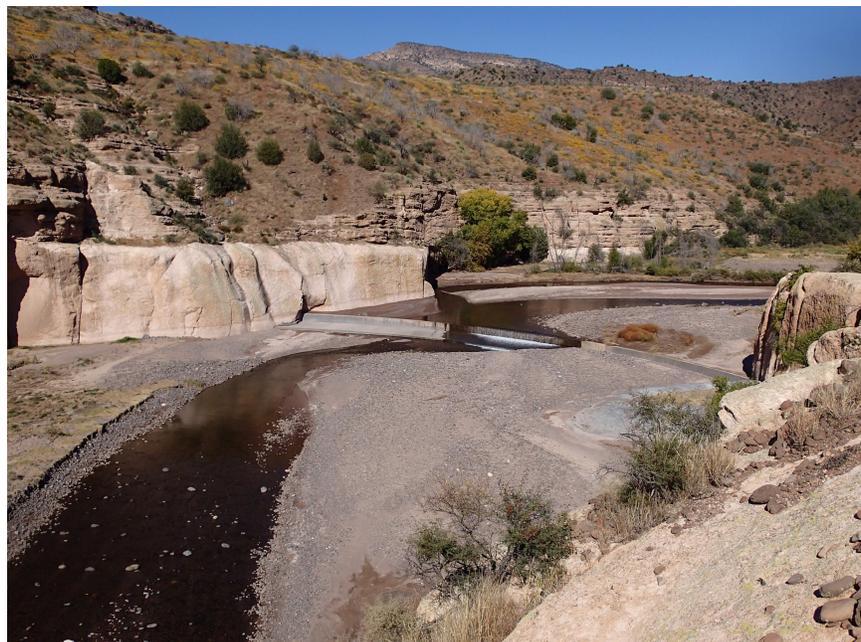
To protect native species in Blue River from non-native fishes in the San Francisco River, Reclamation constructed a fish barrier (cover photo) on Blue River approximately 0.8 km upstream from its mouth. The barrier was completed in June 2012. Immediately following closure of the barrier, roundtail chub *Gila robusta* and spinedace *Meda fulgida* were stocked in attempt to establish new populations of these two native fishes.

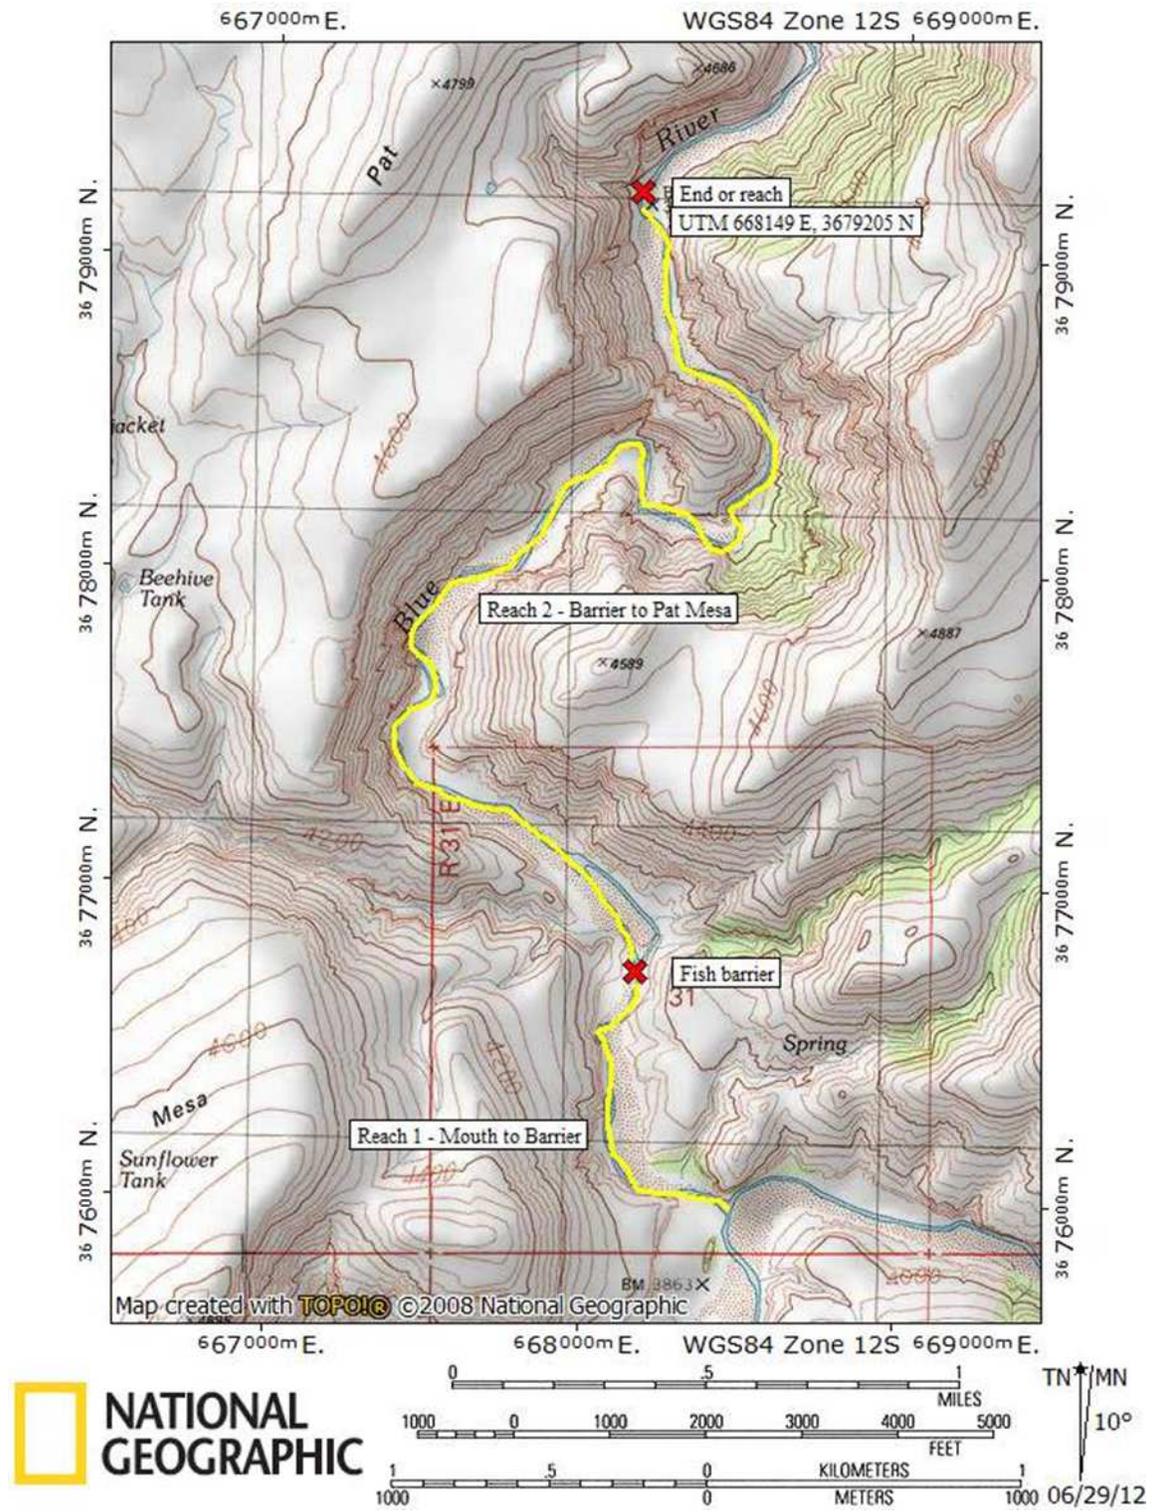
Figure 1. Map of lower Blue River, Greenlee County, Arizona, showing location of fish barrier and sampling Reaches 1 & 2. Map locations provided by Reclamation.

The constructed fish barrier on lower Blue River (Figure 1) is located near UTM 668124E 367503E (NAD83) and is accessed from downstream by vehicle via Martinez Ranch Road to a primitive road along the San Francisco River to Blue River (obliterated by flooding in mid-September 2013), from upstream by 12 km hike down river from Juan Miller Crossing (Forest Service Road 475), or via helicopter. The portion of Blue River to be monitored included two segments: Reach 1 from San Francisco River to the fish barrier, and Reach 2 from the fish barrier upstream to Pat Mesa (Figure 1). Reach 2 was further subdivided into 23, 200-m long sub-reaches, consecutively numbered 1-23, upstream from the fish barrier. We visited the area on October 21 and November 4, 2013 and followed most protocols and procedures described by Clarkson et al. (2011); we followed AZGFD (2012) with respect to site lengths (200-m) and fish measurements.

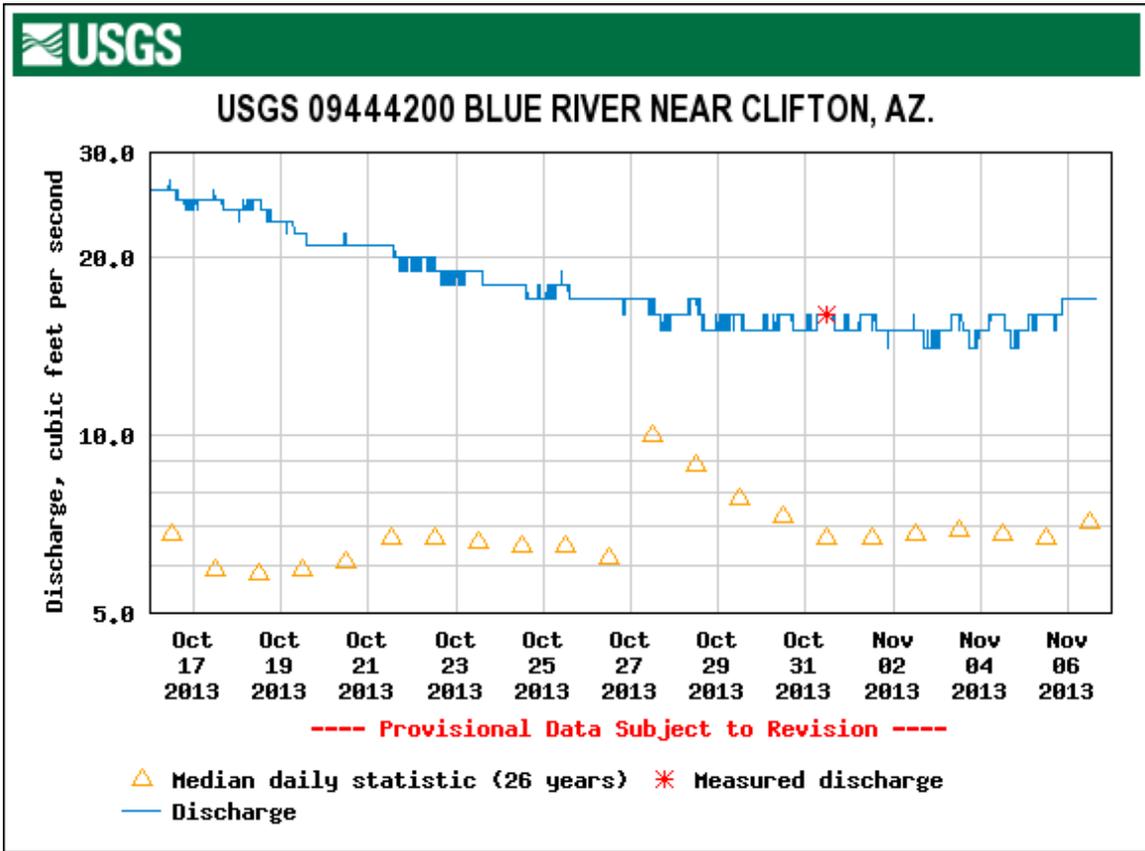
Figure 2. Discharge in Blue River, Greenlee Co., Arizona during and prior to the period of fish monitoring October 21 and November 5, 2013. The gauge site is at Juan Miller crossing (Forest Service Road 475) about 12 km upstream of the barrier.

We visited lower Blue River below the barrier on October 21, 2013 (via Martinez Ranch) and above the barrier on November 4, 2013 (via Juan Miller crossing). Discharge at times of our visits was approximately 20-15 cfs at the Juan Miller gage upstream of our study area (Figure 2). The stream channel immediately above the barrier was shallow and relatively wide (cover photo taken October 21, 2013), but there was no deep reservoir-pool, and immediately downstream of the barrier apron the stream was similar. Habitat down- and upstream was shallow riffles and relatively few deep pools, and substrates were largely clean and loose with few fines. There was little evidence of ash derived from the Wallow Fire in the upper watershed in summer 2011, and which blanketed substrates the previous autumn (Marsh et al. 2012). Weather was clear and cool, and water clarity was high, so conditions were ideal for stream sampling and visual inspection of pools. Debris high on canyon walls (e.g., Figure 3) was evidence of flooding that exceeded 10,000 cfs on September 15, 2013 (USGS 2013), and likely cleaned and sorted substrates throughout the stream.

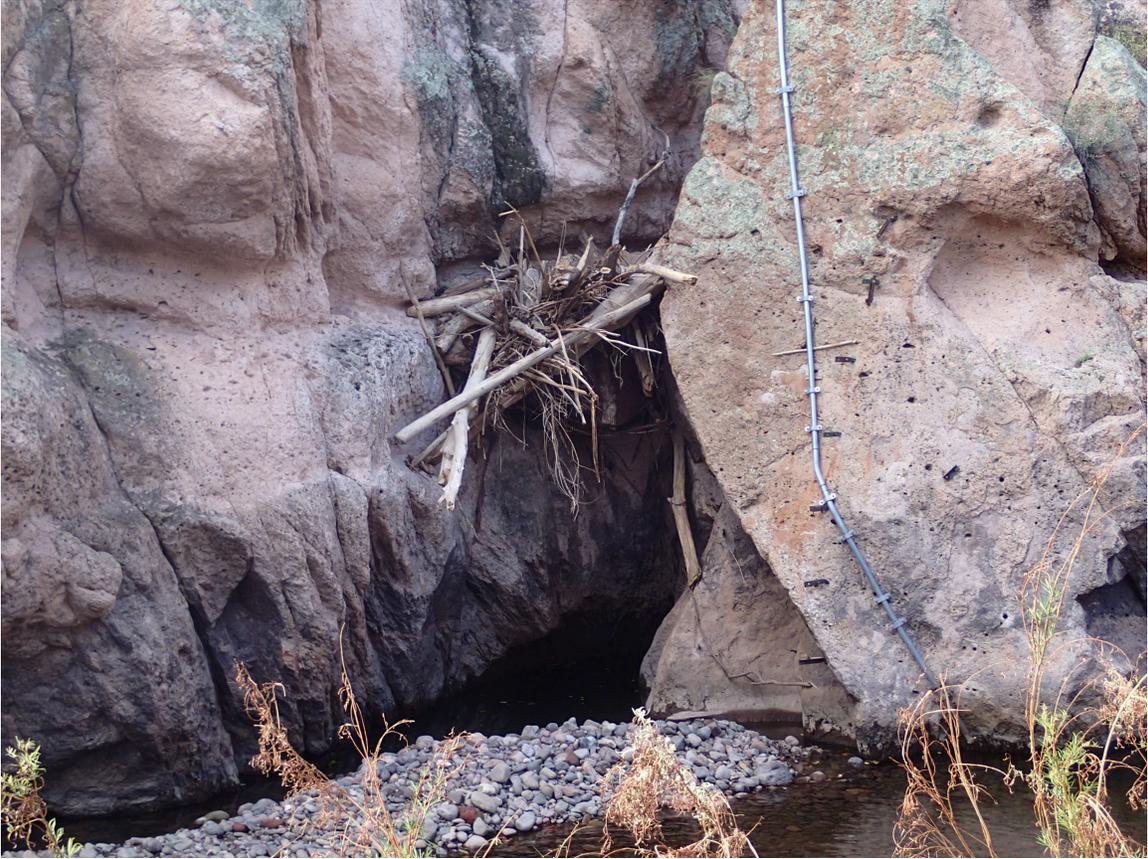
Figure 3. Blue River, Greenlee Co., Arizona, showing debris deposited about 3 m above the stream channel presumably during flooding on September 15, 2013. The location is at the USGS stream gauge site at Juan Miller crossing (Forest Service Road 475) about 12 km upstream of the barrier. Photo by RWC taken November 4, 2013.
